JOINT PHOTOGRAPHIC INTELLIGENCE BRIEF

SUBJECT: Similarity of Probable Assembly and
Checkout buildings at Semipalatinsk
Airfield and Kapustin Yar/Vladimi-
rovka Missile Test Center.

NO : PIC/JB-9/60
DATE: 26 January 1960

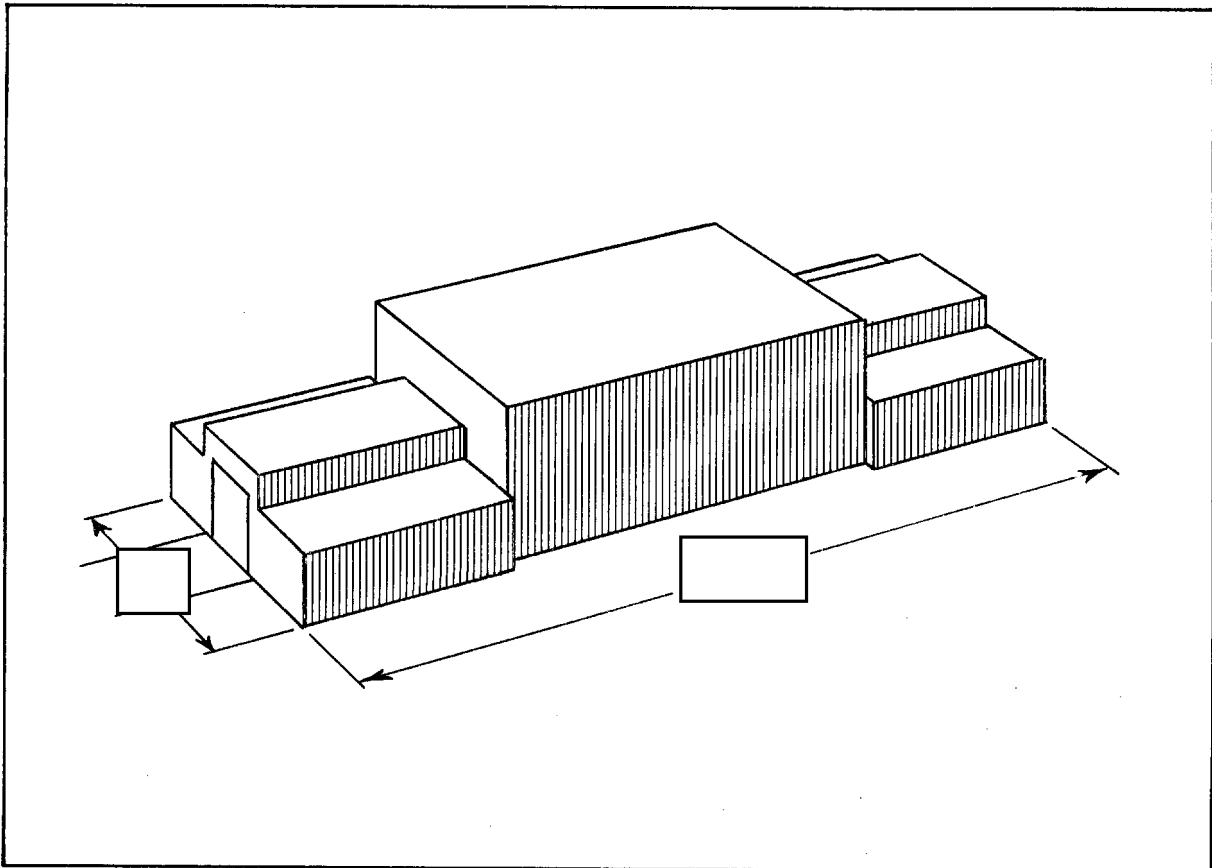
These buildings are large rectangular, drive-through structures with
high center sections between single-story monitor-roofed end sections. Large
doors in the end sections extend up into the monitors. A typical building is
illustrated on the following page.

The dimensions shown represent the range of measurements obtained for the five buildings. Since the degree of difference is so small, it is probable that all five buildings are actually the same size.
